USS YORKTOWN CG-48
SEMAT II SHELL CONDITION
ASSESSMENT SURVEY
INTERIOR AREAS
12/02/01 TO 12/14/01

PREPARED BY SUPERVISOR
OF
SHIPBUILDING CONVERSION AND REPAIR
PORTSMOUTH VIRGINIA
12/13/01

14 December 2001
Serial # 1697BA-022

USS YORKTOWN (CG-48)
SHELL CONDITION ASSESSMENT SURVEY, INTERIOR AREAS.

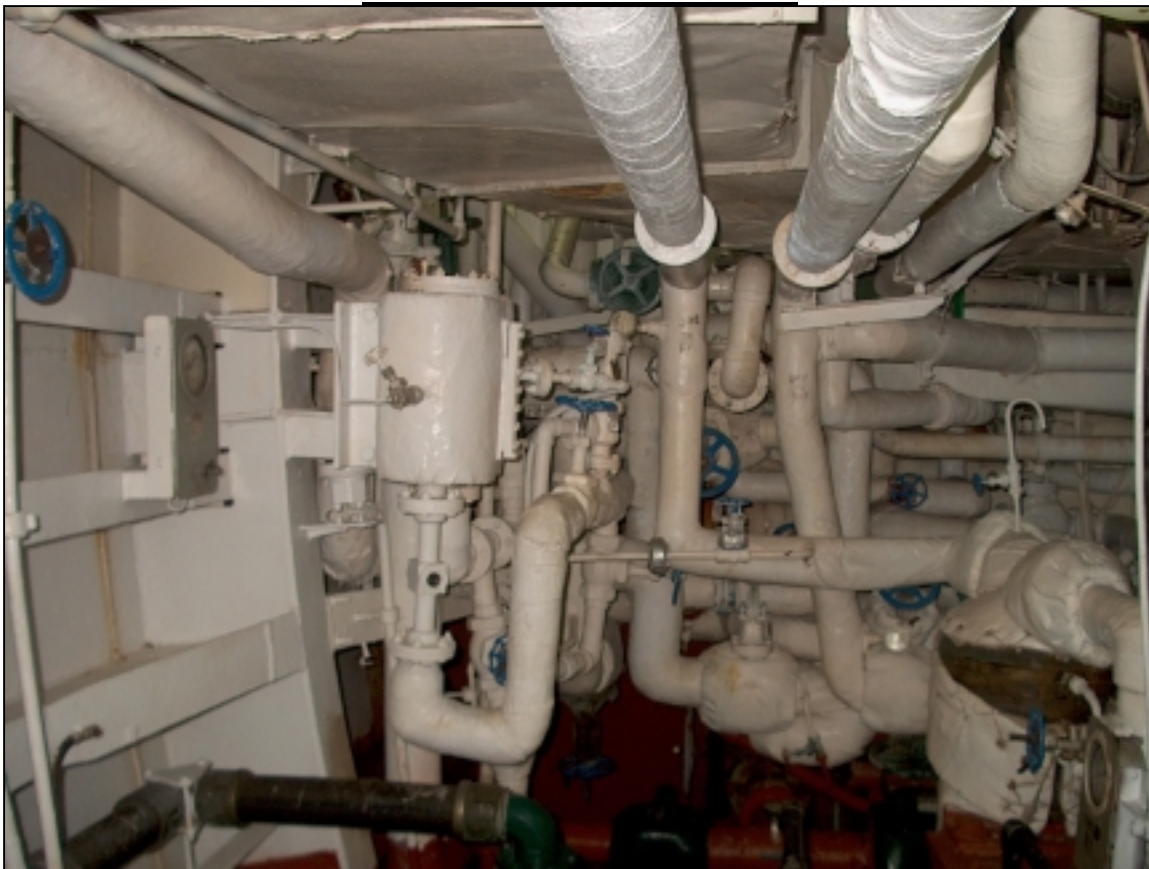
“CONDENSATE CORNER” LOOKING FORWARD AT BHD (300), DETERIORATED STRINGERS WERE FOUND IN THIS AREA.

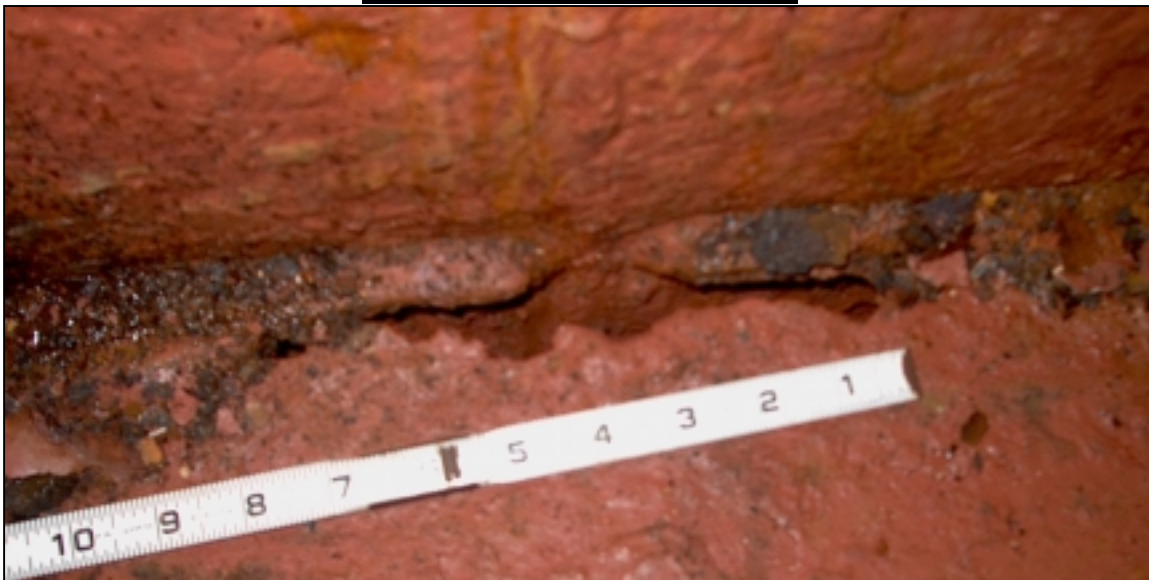
3RD STRINGER FROM MARGIN PLATE APPROXIMATELY 4' AFT OF BHD (300)

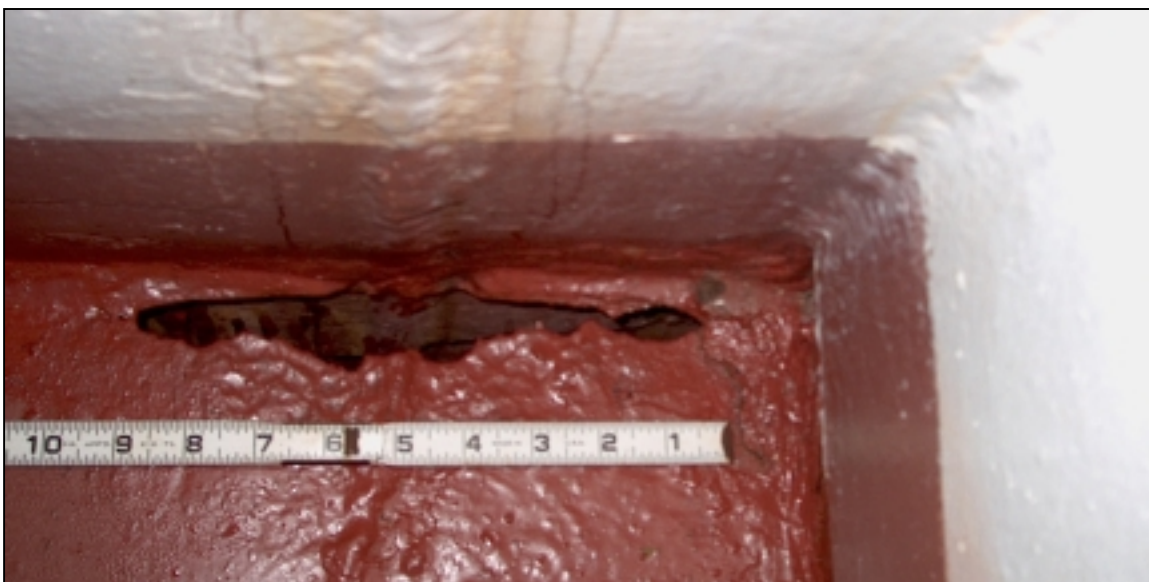
4TH STRINGER FROM MARGIN PLATE AT WEB FRAME (308)

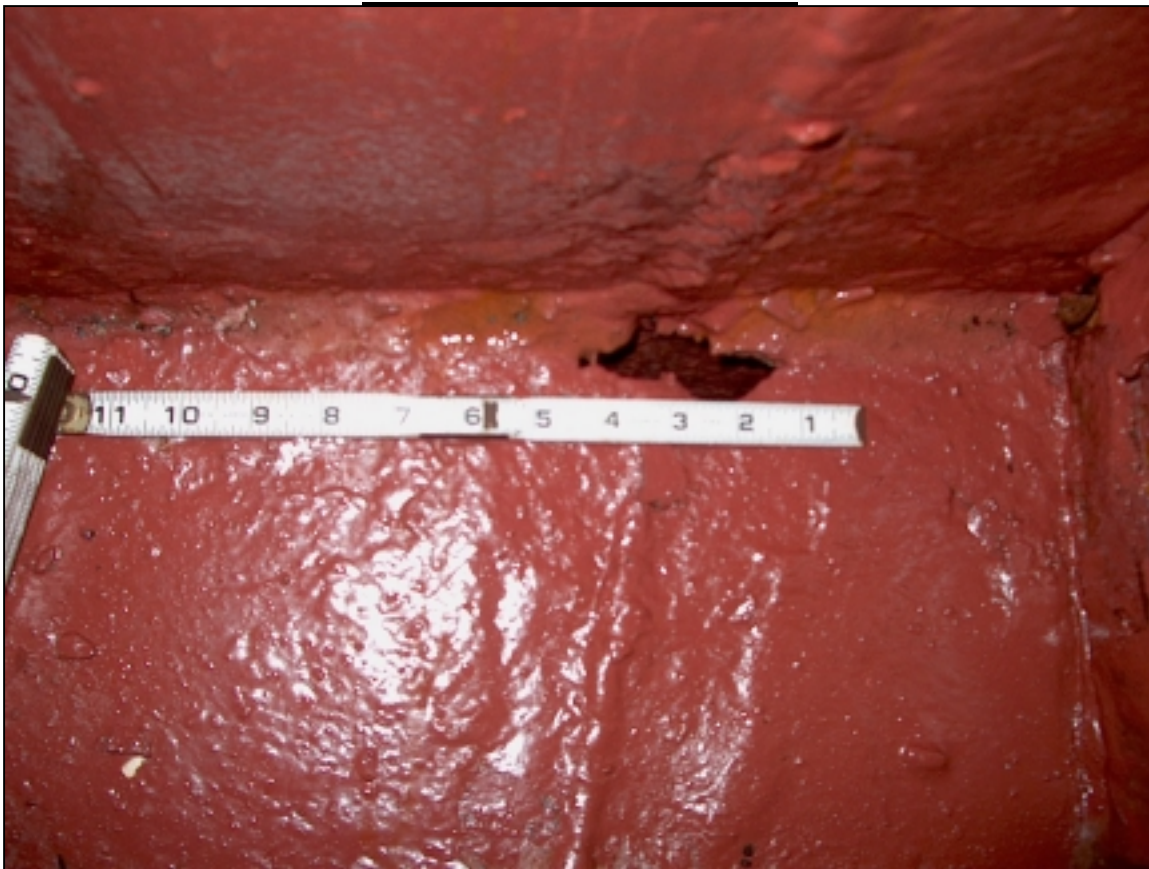
3RD STRINGER FROM MARGIN PLATE AT WEB FRAME (308), WEB IS DETERIORATING AT WEEP HOLE.

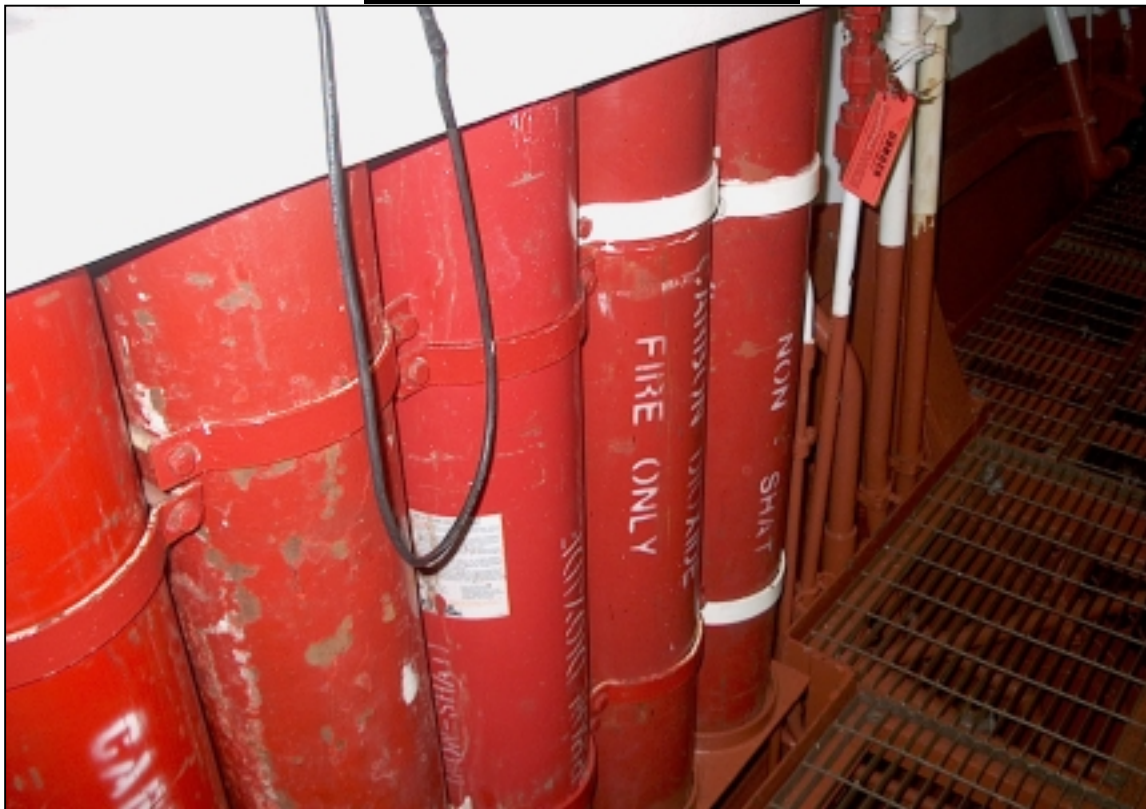
HALON BOTTLE STATION BETWEEN WEB FRAMES (324-332), DETERIORATED STRINGERS WERE FOUND OUTBOARD OF BOTTLES.

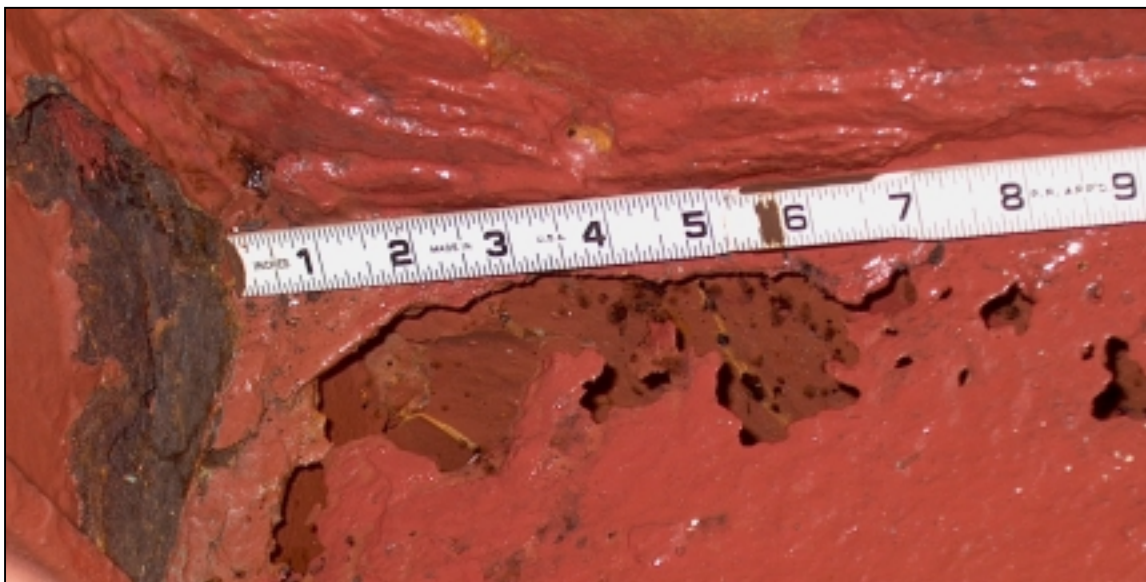
3rd STRINGER FROM MARGIN PLATE APPROXIMATELY 3' AFT OF WEB FRAME (324)

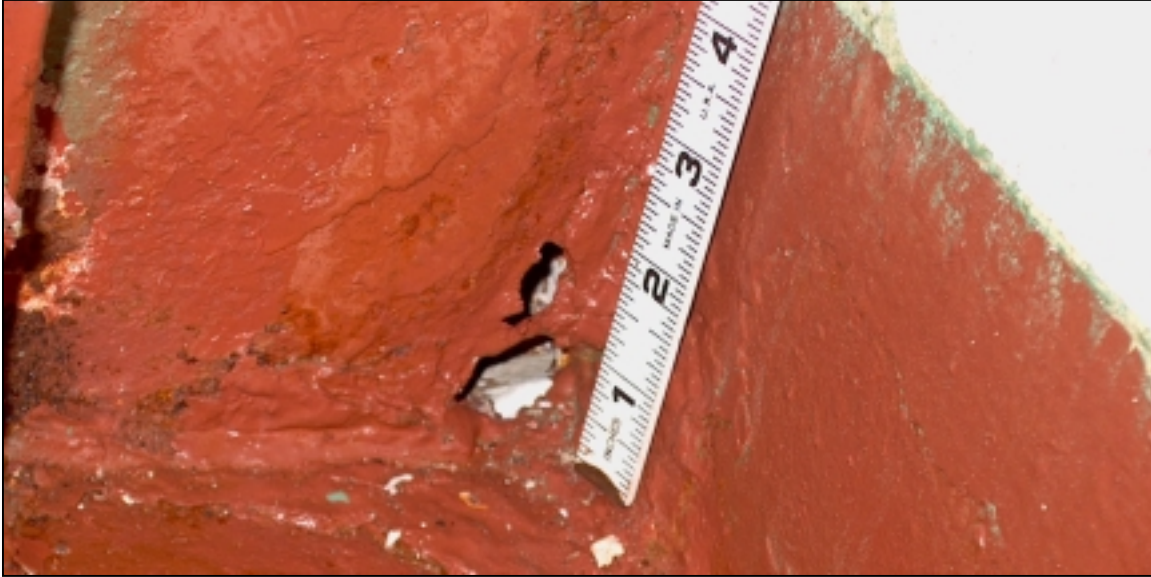
TOP PICTURE VERTICAL STIFFENER (6 X 4 T-BEAM) APPROXIMATELY 3' AFT OF WEB FRAME (324).

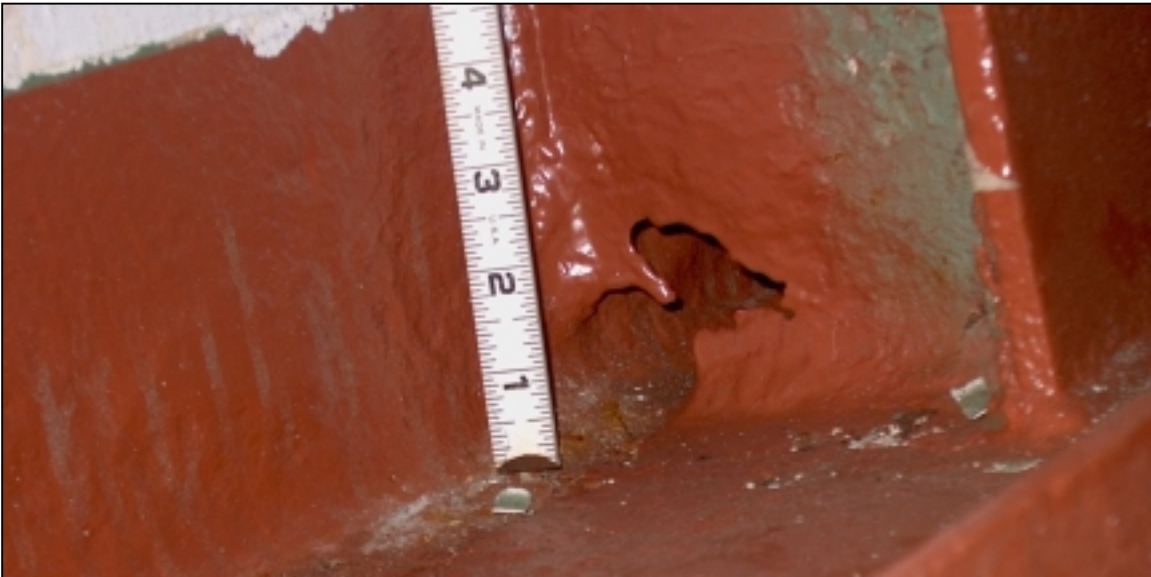
BOTTOM PICTURE VERTICAL STIFFENER APPROXIMATELY 6' AFT OF WEB FRAME (324). ALL THREE VERTICAL STIFFENERS BETWEEN WEB FRAMES (324-332) FROM 3RD STRINGER TO APPROXIMATELY 1' ABOVE 4TH STRINGER ARE DETERIORATED.

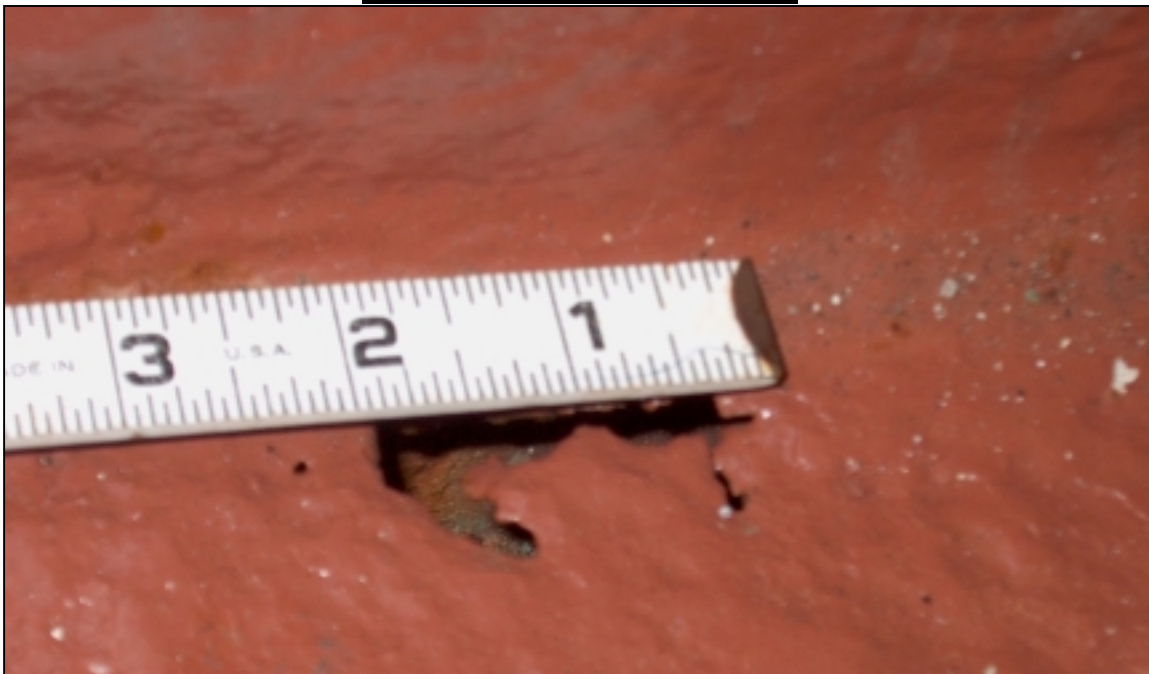
3RD STRINGER FROM MARGIN PLATE APPROXIMATELY 3' FORWARD OF WEB FRAME (332)

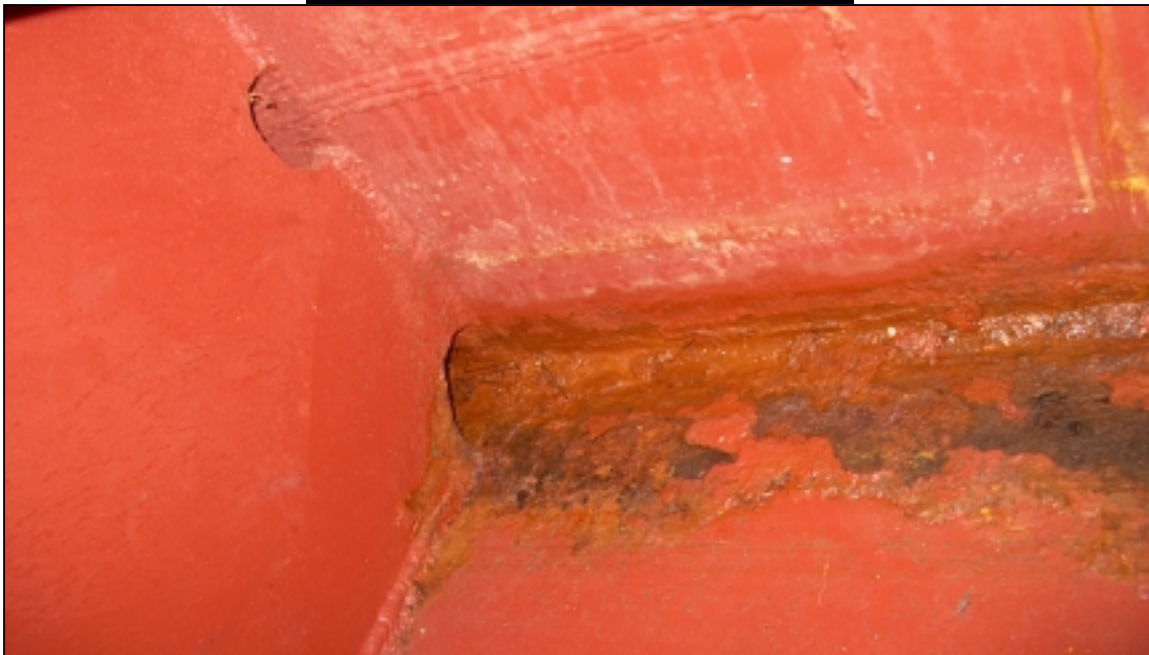
SAFETY HAZARD: 1. SERIOUS - CORRECT AS SOON AS POSSIBLE 2. SERIOUS - SUSPENSION OF EQUIPMENT/SYSTEM/SPACE REQUIRED 3. SERIOUS - WAIVER OF EQUIPMENT/SYSTEM 4. SAFETY ITEM - MINOR 5. COMBUSTIBLE MATERIAL		1. MAINTENANCE ACTION COMPLETED: PARTS DRAWN FROM SUPPLY 2. MAINTENANCE ACTION COMPLETED: REQUIRED PARTS NOT DRAWN FROM SUPPLY 3. MAINTENANCE ACTION COMPLETED: NO PARTS REQUIRED 4. CANCELLED - DEFERRAL WILL BE REMOVED FROM CSMP 5. MAINTENANCE ACTION COMPLETED: 3-M CAPABILITY UTILIZED 6. NONE OF THE ABOVE, DESCRIBE IN REMARKS/DESCRIPTION SECTION			1. MANDATORY 2. ESSENTIAL 3. HIGHLY DESIRABLE 4. DESIRABLE
DISCREPANCY DESCRIPTION: PER SEMAT II UNDERWATER HULL ASSESSMENT: STBD SIDE (5-300-0-E) MAIN ENGINE ROOM 2 LOWER LEVEL					
2 ND STRINGER FROM MARGIN PLATE (24 X 8 T-BEAM) BETWEEN BHD (300) AND WEB FRAME (324) HAS TRAPPED WATER					
SURFACE RUST AND HEAVY PAINT SEPARATION. APPROXIMATELY 50 SF.

HEAVY PAINT SEPARATION ON SHELL AND 2ND STRINGER (24 X 8 T-BEAM)
APPROXIMATELY 4' FWD OF WEB FRAME (324).

RECOMMENDED REPAIRS: RECOMMEND SHIPS FORCE CLEAN AREA TO BARE METAL APPROXIMATELY 50 SF. PRIME AND PAINT					
SSPORT C221 POC: B. WILLIAMS (757) 396-4001 EXT 2166, TPOC: M. MELVIN (757) 396-4001 EXT 2128					
CSMP SUMMARY: TRAPPED WATER / CORROSION ON 2 ND STRINGER BETWEEN BHD (300) & WEB FRAME (324)				TEST# MRC 1102/1	
ROOT CAUSE/AMPLIFICATION: H1				STEP# 1,2,3,4 & 5	
SYSTEM LEVEL IMPACT:					
PART NO.	NOMEMCLATURE		QTY	NSN	COST
1					
2					
3					
4					
FIRST CONTACT BAILEY	RATE DC1	SECOND CONTACT WATSON	RATE HT1	PHONE	
ASSESSOR / ACT / TECH ID# J. LaROCK/ T. ILGENFRITZ QED SYSTEMS INC.			TD	TL	LOGISTICIAN TSP

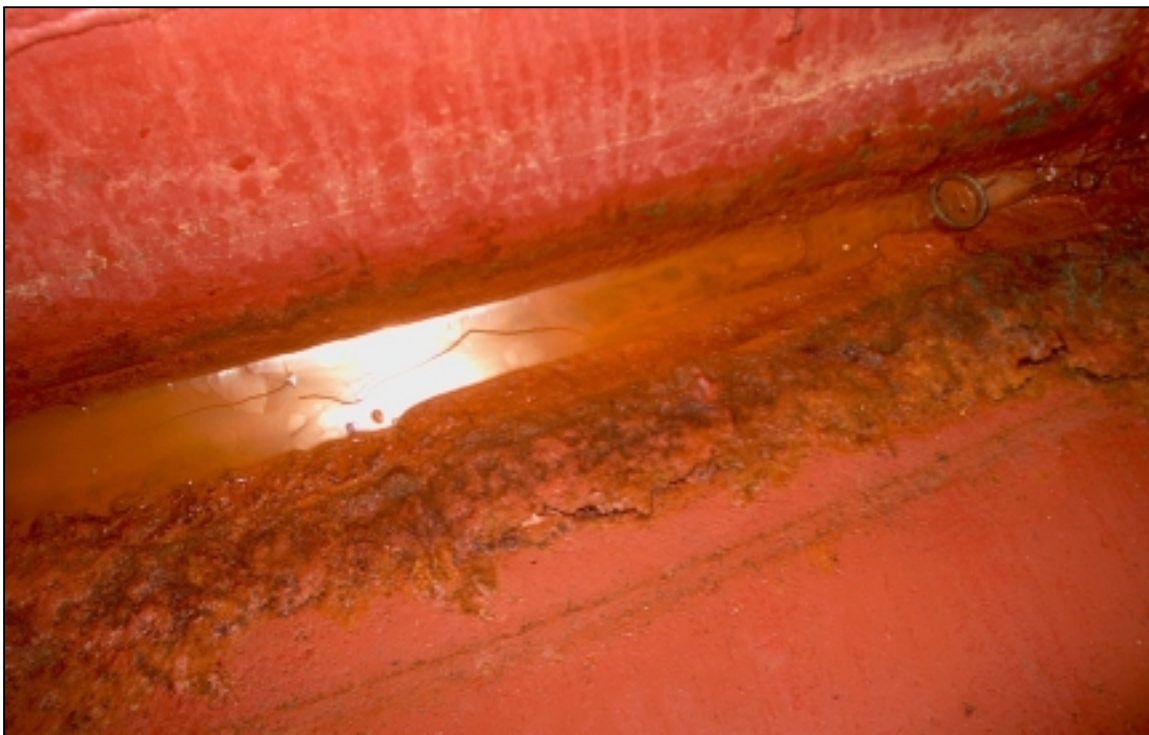
TRAPPED WATER , HEAVY PAINT SEPARATION ON 2ND STRINGER BETWEEN WEB FRAMES
(308-316).

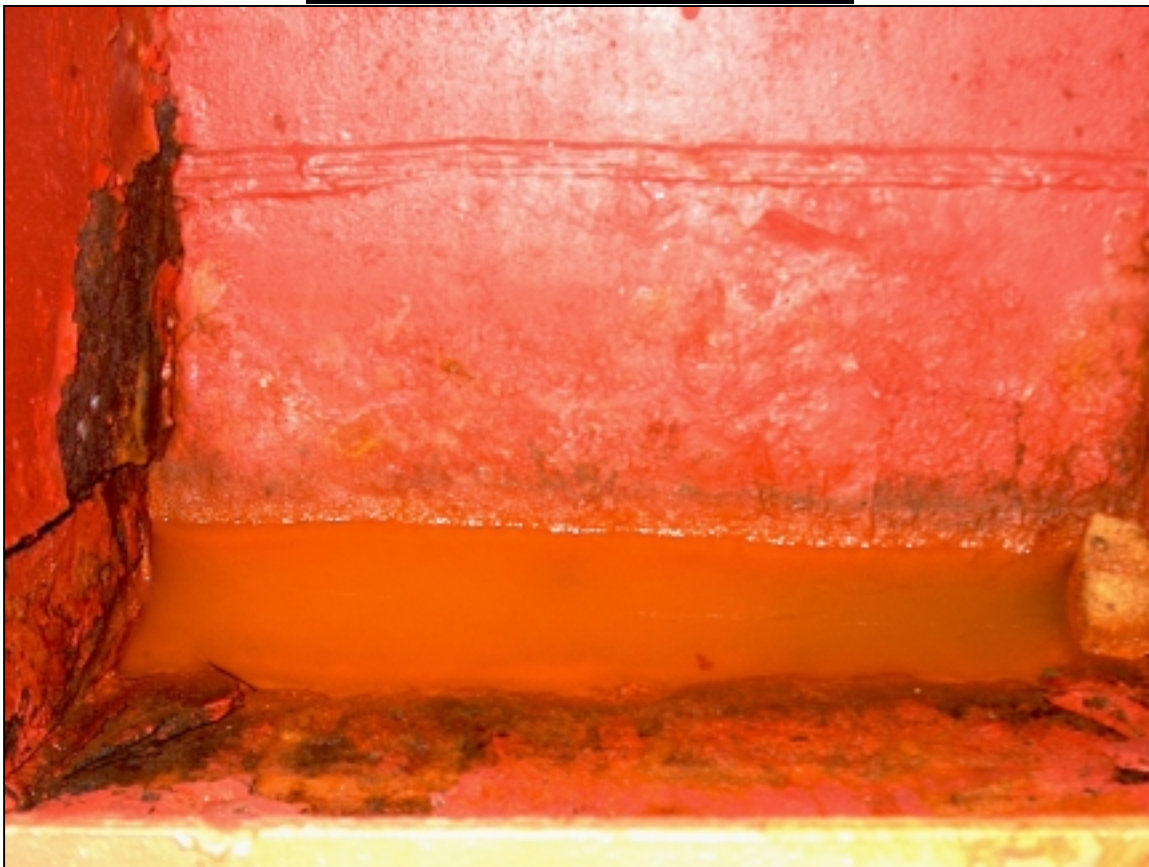
TRAPPED WATER AND CORROSION ON 2ND STRINGER BETWEEN BHD (300) AND WEB
FRAME (308).

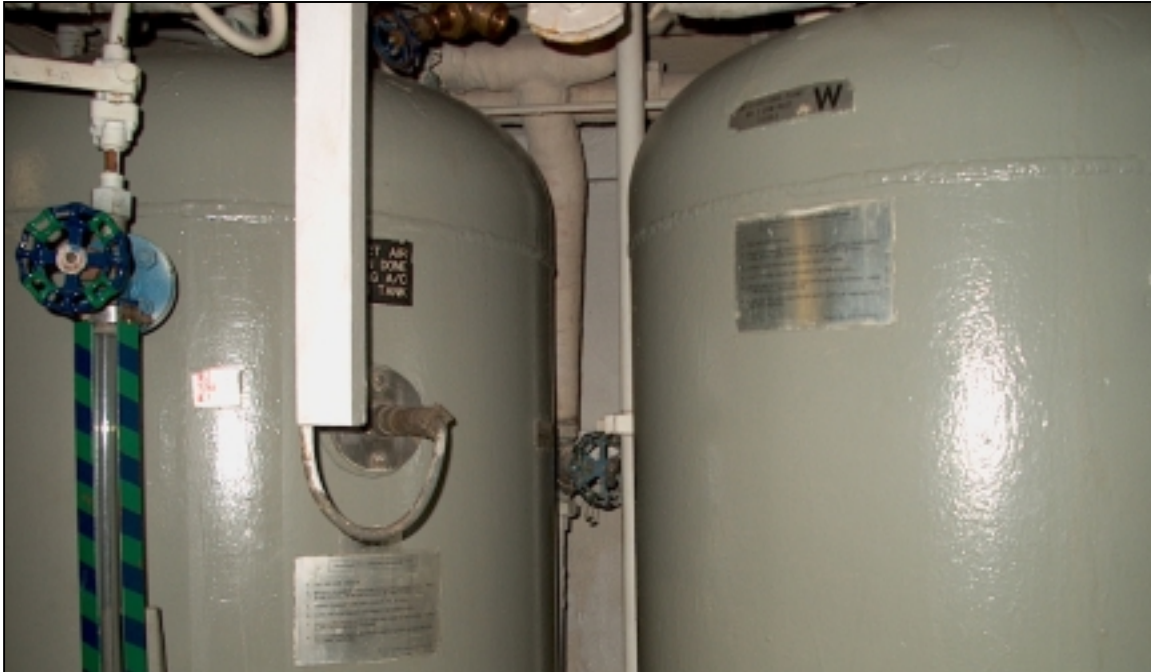
CHILLED WATER EXPANSION TANKS 1 & 2 AT WEB FRAME (236). DETERIORATED STRINGERS WERE DISCOVERED OUTBOARD OF TANKS.

RECOMMENDED REPAIRS: RECOMMEND REPAIR ACTIVITY, REMOVE CHW TANKS 1 & 2 FROM THEIR FOUNDATIONS, CUT OUT 2 ND STRINGER FROM DECK FROM WEB FRAME (236-244) APPROXIMATELY 8 LF; REPLACE WITH (10 X 4 X 11.55 T-BEAM), REPLACE TANKS. CUT OUT 1 ST AND 2 ND STRINGER FROM BHD (260) TO APPROXIMATELY 6' FWD EACH, 12' TOTAL. REPLACE WITH (10 X 4 X 11.55 T-BEAM). PERFORM NDT, PRIME AND PAINT AREAS DISTURBED BY REMOVALS. INSIDE / OUTSIDE OF HULL. WORK TO BE ACCOMPLISHED DURING DRYDOCK AVAILABILITY.					
SSPORT C221 POC: B. WILLIAMS (757) 396-4001 EXT 2166, TPOC: M. MELVIN (757) 396-4001 EXT 2128					
CSMP SUMMARY: STRINGERS ARE DETERIORATED FROM WEB FRAME (236) TO BHD (260), PORT SIDE. U/L				TEST# MRC 1102/1	
ROOT CAUSE/AMPLIFICATION: H1				STEP# 1,2,3,4 & 5	
SYSTEM LEVEL IMPACT:					
PART NO.	NOMENCLATURE		QTY	NSN	COST
1					
2					
3					
4					
5					
6					
FIRST CONTACT BAILEY	RATE DC1	SECOND CONTACT WATSON		RATE HT1	PHONE

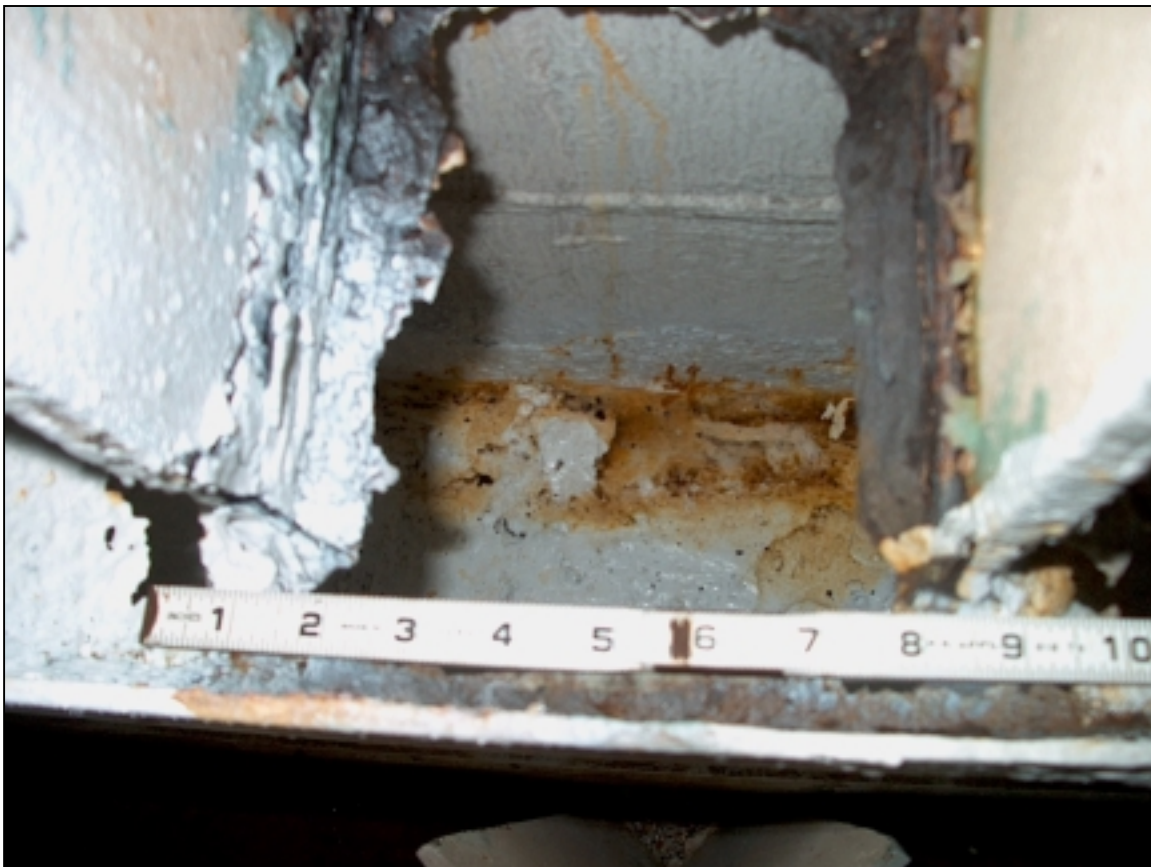
2ND STRINGER FROM DECK APPROXIMATELY 2' AFT OF WEB FRAME (236)
ENTIRE WEB IS GONE.

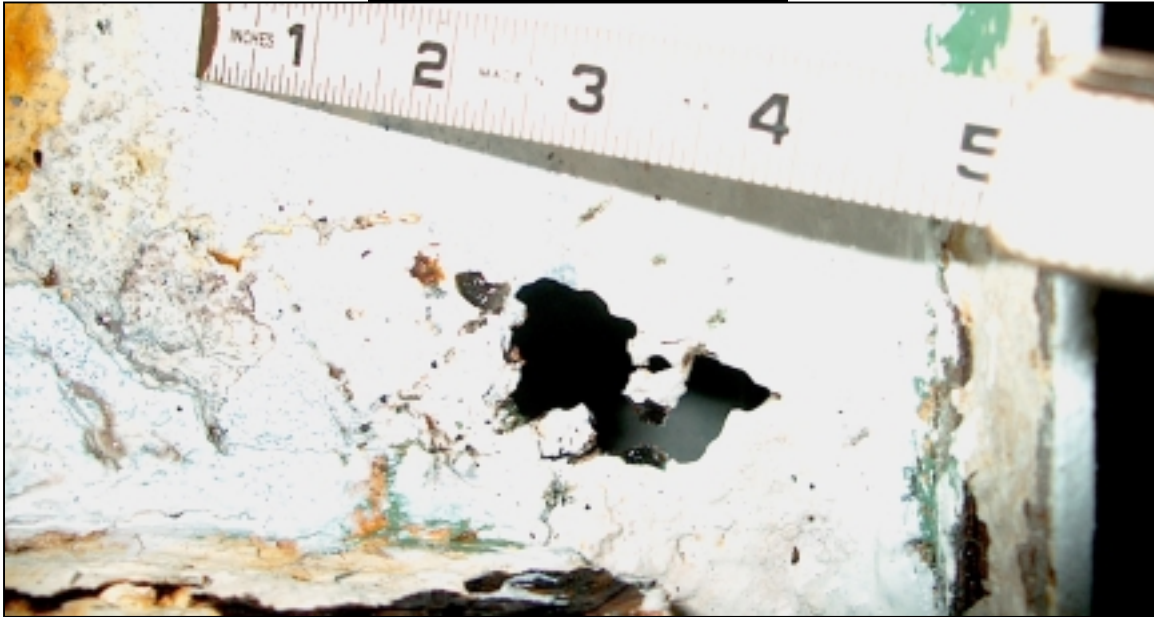
2ND STRINGER FROM DECK APPROXIMATELY 2' FWD OF WEB FRAME (244).

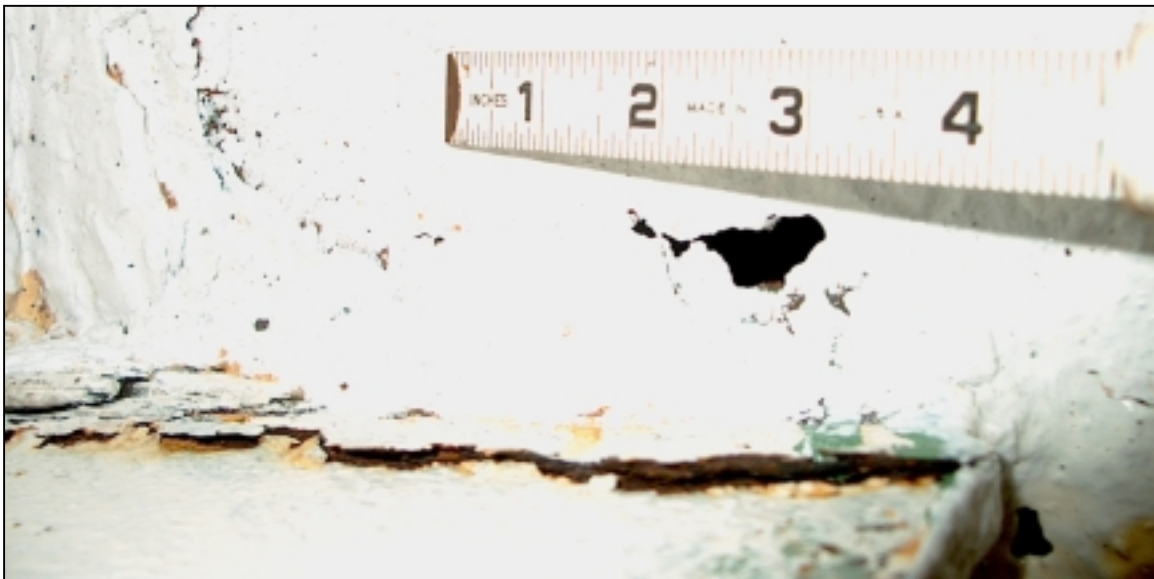
2ND STRINGER FROM DECK APPROXIMATELY 2' FWD OF WEB FRAME (244), INSIDE
SUPPORT BRACKETS FOR NO. 2 CHILLED WATER EXPANSION TANK.

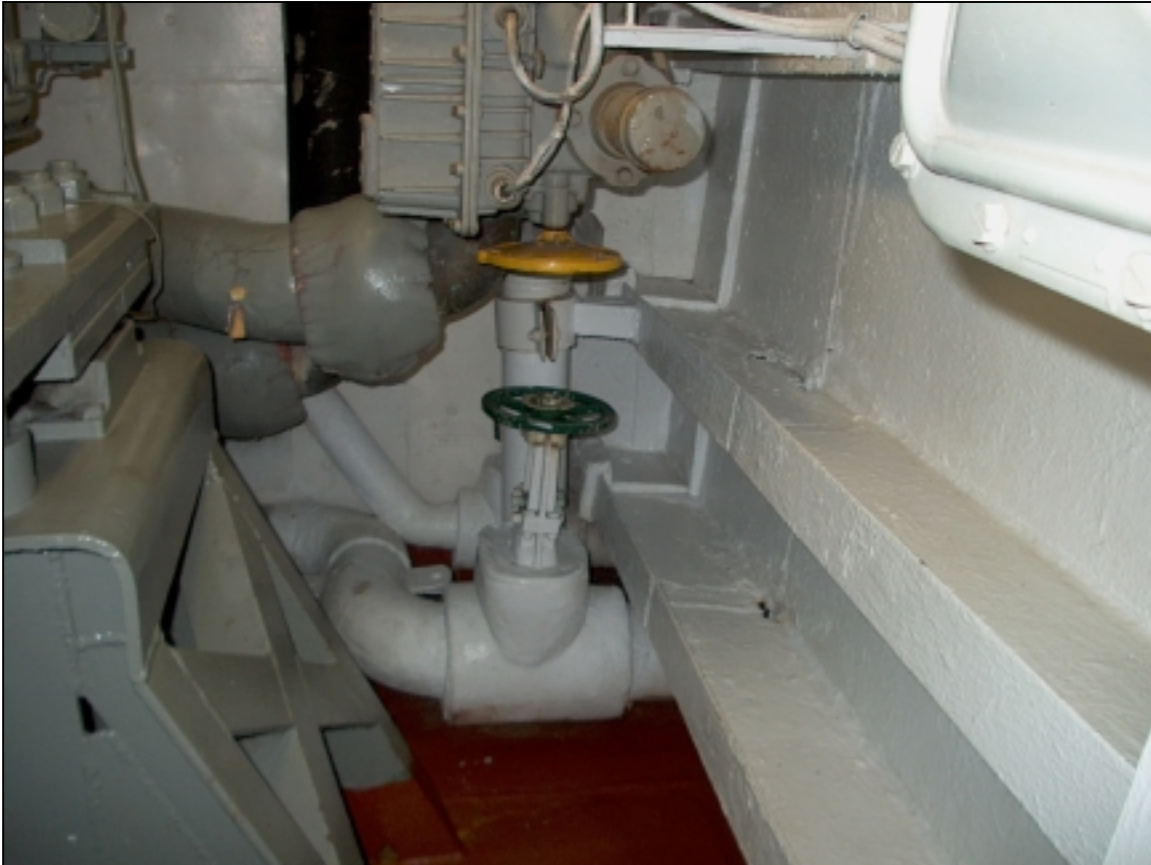
SAFETY HAZARD: 1. SERIOUS - CORRECT AS SOON AS POSSIBLE 2. SERIOUS - SUSPENSION OF EQUIPMENT/SYSTEM/SPACE REQUIRED 3. SERIOUS - WAVIER OF EQUIPMENT/SYSTEM 4. SAFETY ITEM - MINOR 5. COMBUSTIBLE MATERIAL		1. MAINTENANCE ACTION COMPLETED: PARTS DRAWN FROM SUPPLY 2. MAINTENANCE ACTION COMPLETED: REQUIRED PARTS NOT DRAWN FROM SUPPLY 3. MAINTENANCE ACTION COMPLETED: NO PARTS REQUIRED 4. CANCELLED - DEFERRAL WILL BE REMOVED FROM CSMP 5. MAINTENANCE ACTION COMPLETED: 3-M CAPABILITY UTILIZED 6. NONE OF THE ABOVE, DESCRIBE IN REMARKS/DESCRIPTION SECTION			1. MANDATORY 2. ESSENTIAL 3. HIGHLY DESIRABLE 4. DESIRABLE
DISCREPANCY DESCRIPTION: PER SEMAT II UNDERWATER HULL ASSESSMENT:PORT SIDE (5-220-0-E) UPPER LEVEL AMR 1					
2 ND STRINGER FROM DECK BETWEEN WEB FRAMES (236-244) OUTBOARD OF CHW EXPANSION TANKS 1 & 2 IS SEVERELY DETERIORATED.					
1 ST AND 2 ND STRINGER FROM DECK OUTBOARD OF A/C PLANT NO. 2 APPROXIMATELY 4' FWD OF BHD (260) ARE HOLED.

A/C PLANT NO. 2 AND SHELL PLATE AT BHD (260). 1ST AND 2ND STRINGERS FROM DECK ARE HOLED APPROXIMATELY 4' FORWARD OF BHD (260).

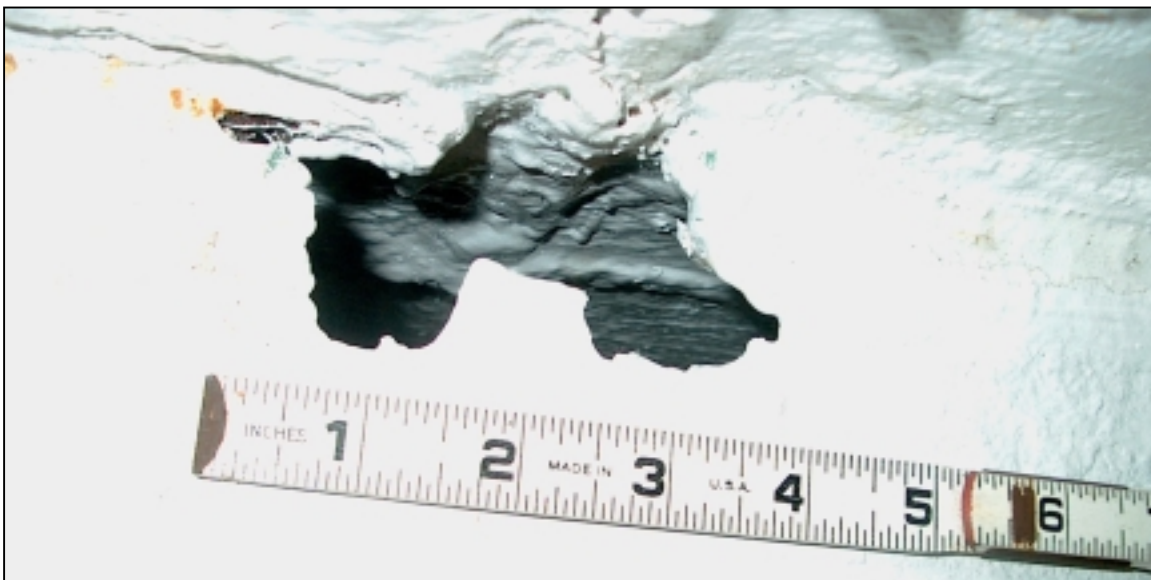
2ND STRINGER FROM DECK APPROXIMATELY 4' FORWARD OF BHD (260).

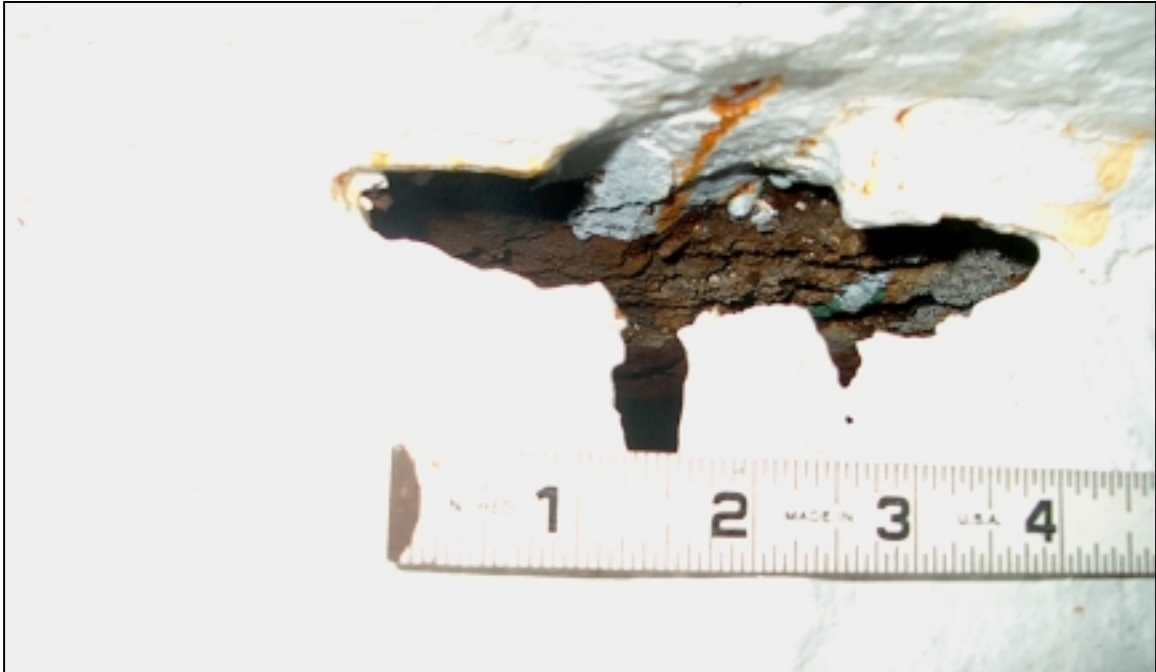
1ST STRINGER FROM DECK APPROXIMATELY 4' FORWARD OF BHD (260).

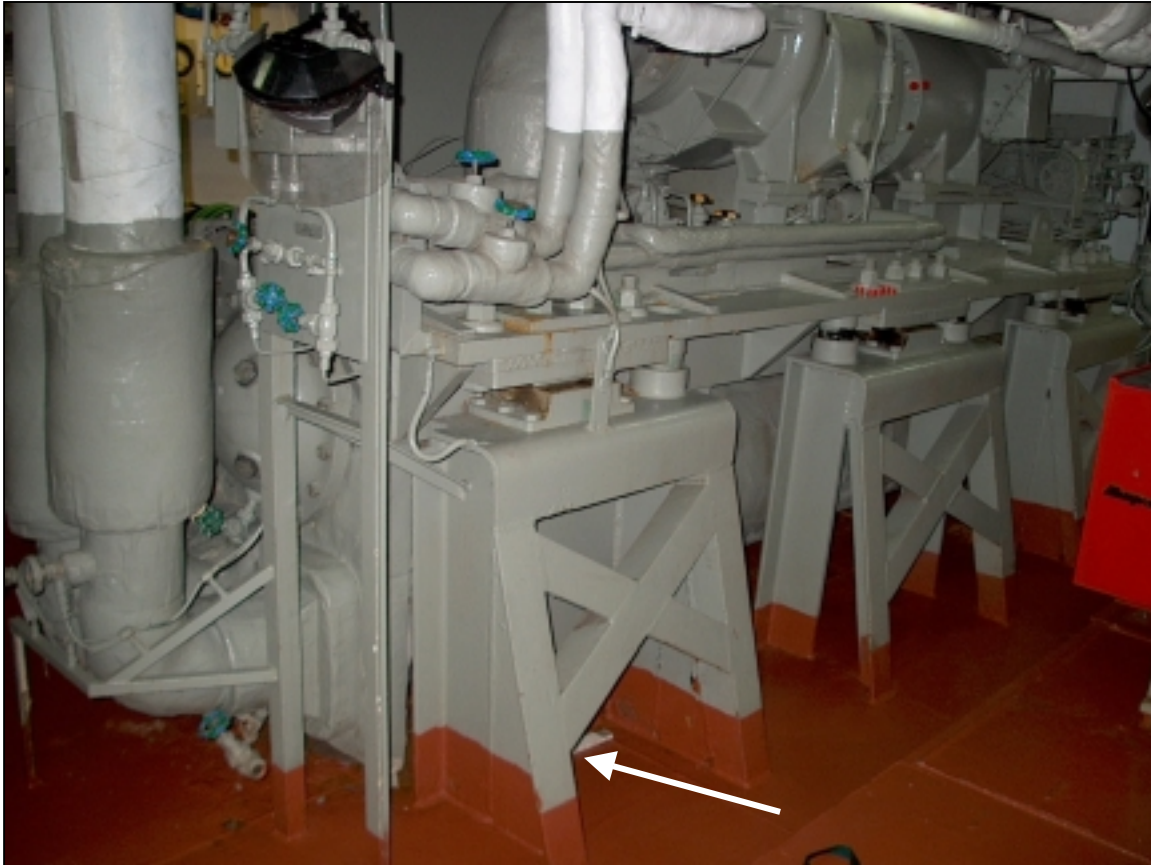
SSPORT C221 POC: B. WILLIAMS (757) 396-4001 EXT 2166, TPOC: M. MELVIN (757) 396-4001 EXT 2128							
CSMP SUMMARY: A/C PLANT NO. 1 INBOARD AFT CORNER FOUNDATION DETERIORATED						TEST# MRC 1102/1	
ROOT CAUSE/AMPLIFICATION: H1						STEP# 1,2,3,4 & 5	
SYSTEM LEVEL IMPACT:							
PART NO.	NOMEMCLATURE			QTY	NSN		COST
1							
2							
3							
4							
5							
6							
FIRST CONTACT BAILEY	RATE DC1	SECOND CONTACT WATSON		RATE HT1	PHONE		
ASSESSOR / ACT / TECH ID# J. LaROCK/T.ILGENFRITZ				TD	TL	LOGISTICIAN	TSP

A/C PLANT NO. 1 INBOARD AFT CORNER FOUNDATION IS DETERIORATED WHERE IT MEETS THE DECK

SAFETY HAZARD: 1. SERIOUS - CORRECT AS SOON AS POSSIBLE 2. SERIOUS - SUSPENSION OF EQUIPMENT/SYSTEM/SPACE REQUIRED 3. SERIOUS - WAIVER OF EQUIPMENT/SYSTEM 4. SAFETY ITEM - MINOR 5. COMBUSTIBLE MATERIAL			1. MAINTENANCE ACTION COMPLETED: PARTS DRAWN FROM SUPPLY 2. MAINTENANCE ACTION COMPLETED: REQUIRED PARTS NOT DRAWN FROM SUPPLY 3. MAINTENANCE ACTION COMPLETED: NO PARTS REQUIRED 4. CANCELLED - DEFERRAL WILL BE REMOVED FROM CSMP 5. MAINTENANCE ACTION COMPLETED: 3-M CAPABILITY UTILIZED 6. NONE OF THE ABOVE, DESCRIBE IN REMARKS/DESCRIPTION SECTION			1. MANDATORY 2. ESSENTIAL 3. HIGHLY DESIRABLE 4. DESIRABLE	
DISCREPANCY DESCRIPTION: PER SEMAT II UNDERWATER HULL ASSESSMENT:PORT SIDE (5-220-0-E) UPPER LEVEL AMR 1 FOUNDATION							
INBOARD AFT CORNER OF A/C PLANT NO. 1 IS DETERIORATED WHERE IT MEETS THE DECK							
RECOMMENDED REPAIRS: RECOMMEND REPAIR ACTIVITY, CUT OUT APPROXIMATELY 2 SF OF FOUNDATION PLATE, REPLACE WITH .375 MILD STEEL, PRIME AND PAINT.

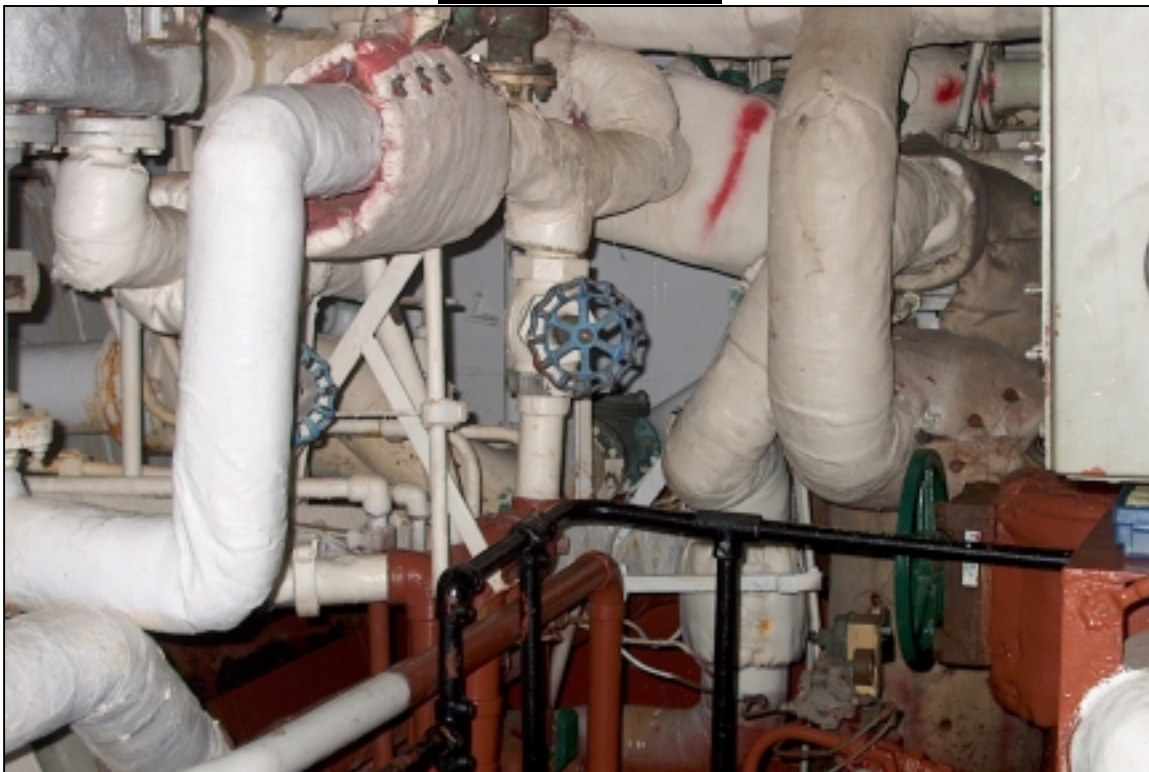
“CONDENSATE CORNER” AT BHD (220)

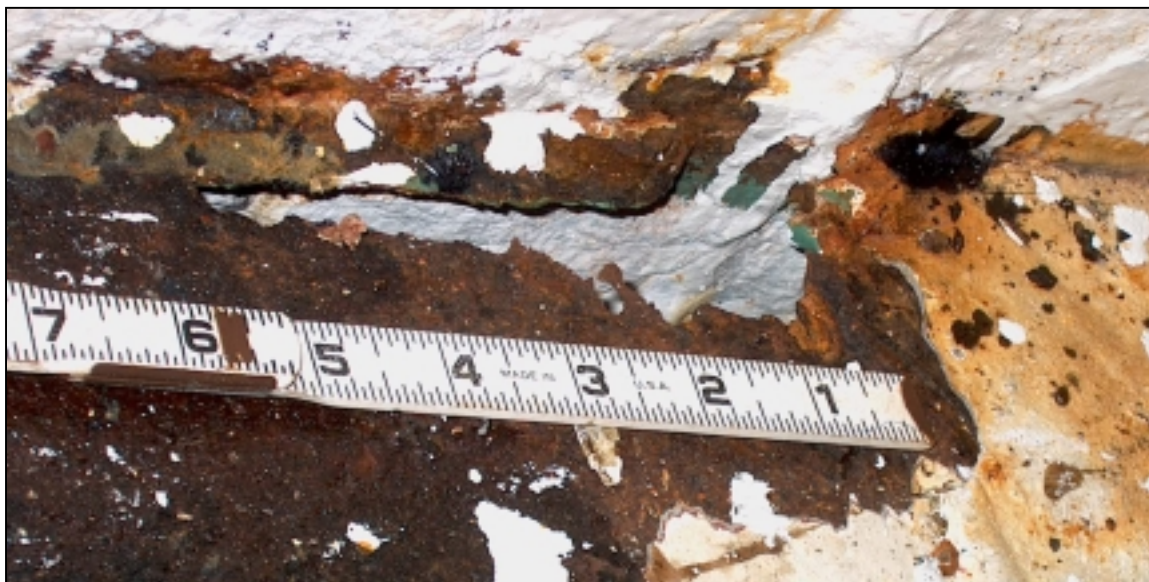
HOLE IN WEB OF 5TH STRINGER FROM MARGIN PLATE APPROXIMATELY 4' FORWARD OF BHD (220). (CSMP/JSN-3812)

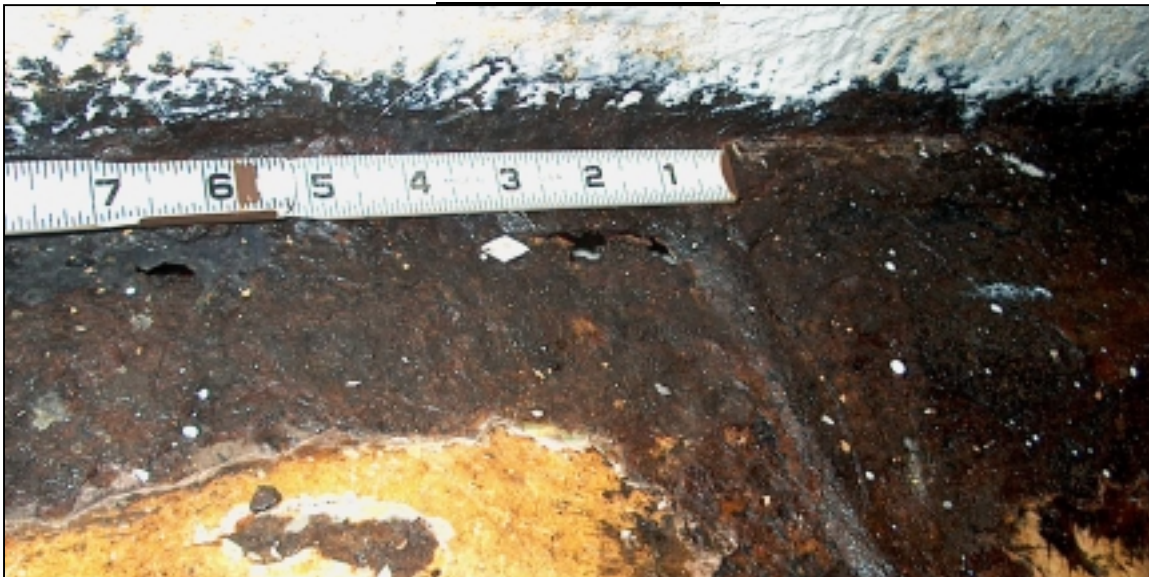
HOLES IN WEB OF 6TH STRINGER FROM MARGIN PLATE BETWEEN BHD (220) AND WEB FRAME (212). (CSMP/JSN-3812)

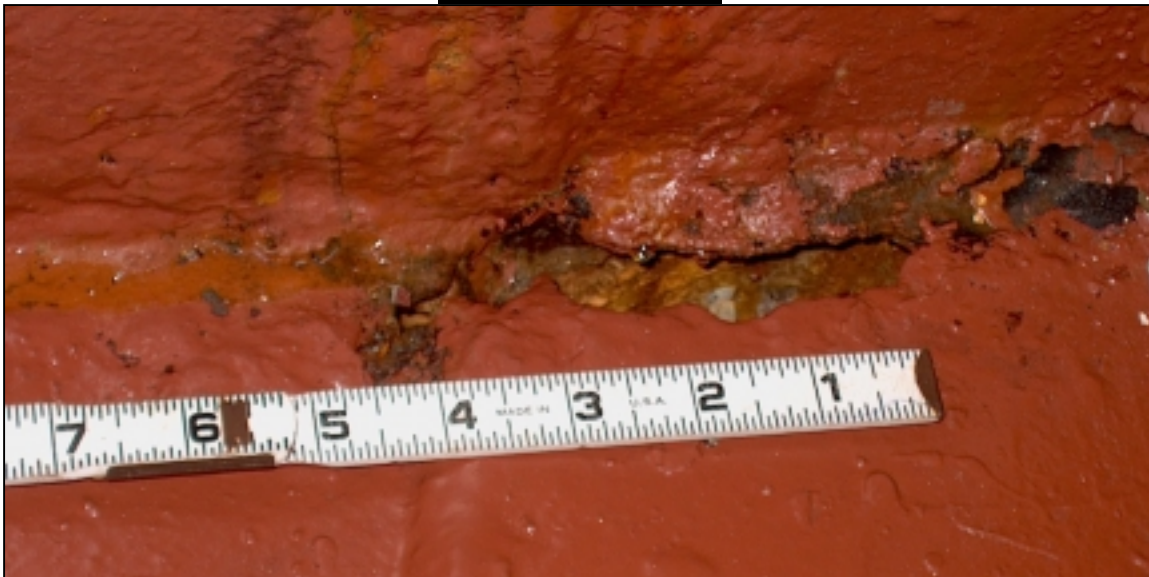
2ND STRINGER FROM MARGIN PLATE AT WEB FRAME (212)
(CSMP/JSN-3812)

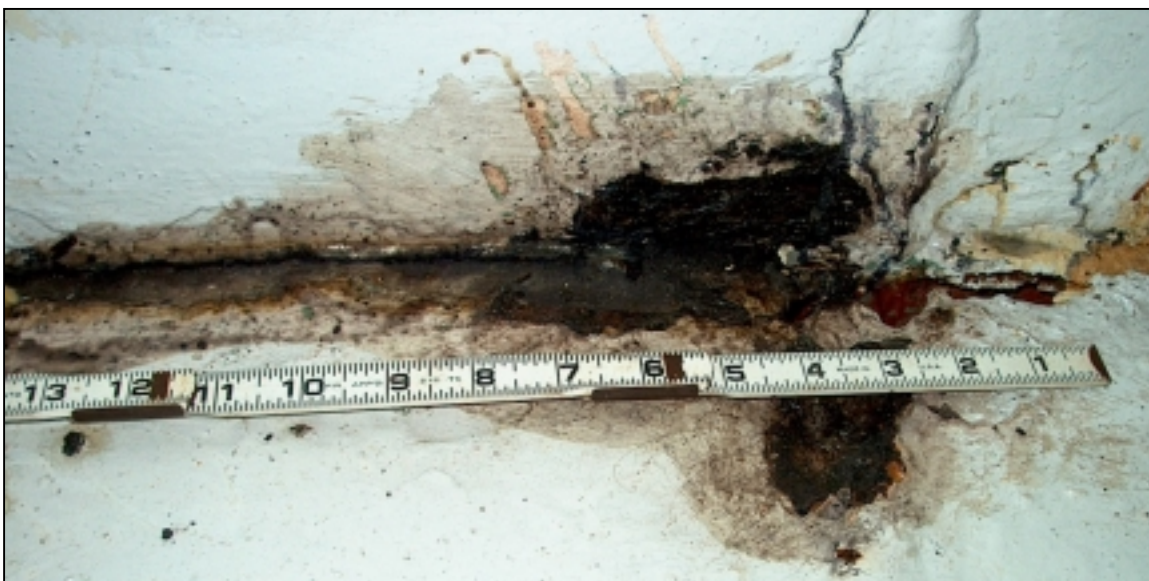
HOLE IN WEB OF 3RD STRINGER FROM MARGIN PLATE AT WEB FRAME (212)
(CSMP/JSN-3812)

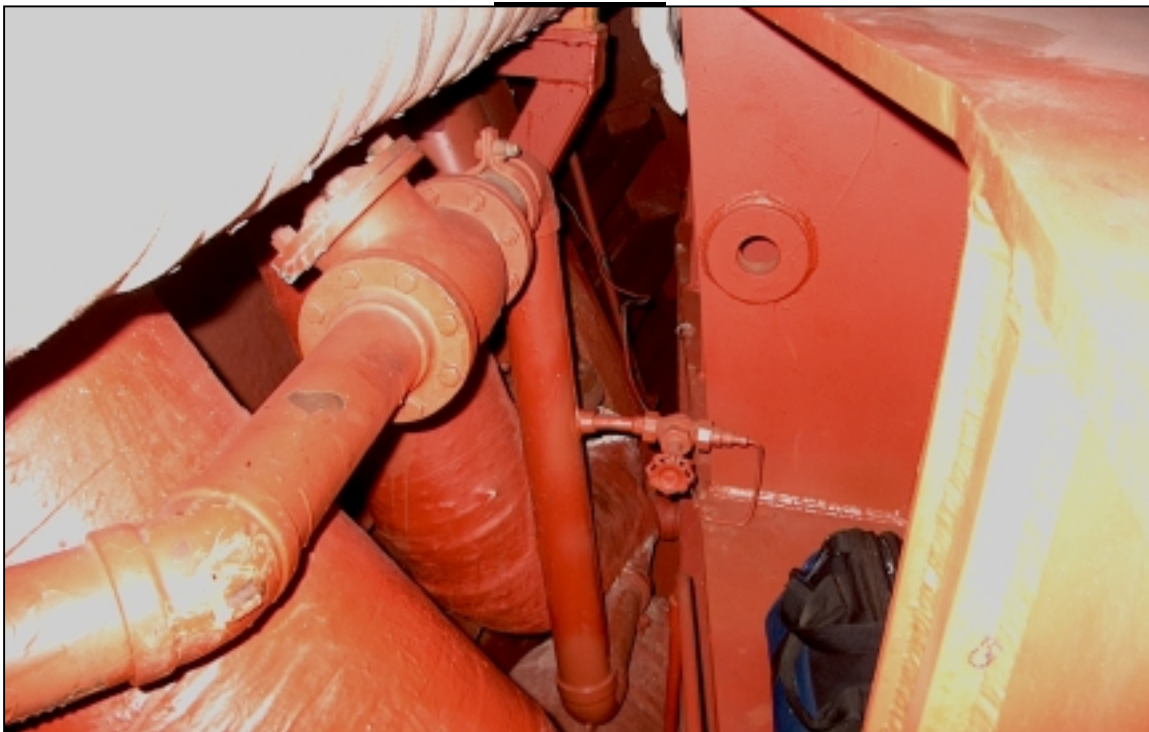
SAFETY HAZARD: 1. SERIOUS - CORRECT AS SOON AS POSSIBLE 2. SERIOUS - SUSPENSION OF EQUIPMENT/SYSTEM/SPACE REQUIRED 3. SERIOUS - WAIVER OF EQUIPMENT/SYSTEM 4. SAFETY ITEM - MINOR 5. COMBUSTIBLE MATERIAL		1. MAINTENANCE ACTION COMPLETED: PARTS DRAWN FROM SUPPLY 2. MAINTENANCE ACTION COMPLETED: REQUIRED PARTS NOT DRAWN FROM SUPPLY 3. MAINTENANCE ACTION COMPLETED: NO PARTS REQUIRED 4. CANCELLED - DEFERRAL WILL BE REMOVED FROM CSMP 5. MAINTENANCE ACTION COMPLETED: 3-M CAPABILITY UTILIZED 6. NONE OF THE ABOVE, DESCRIBE IN REMARKS/DESCRIPTION SECTION			1. MANDATORY 2. ESSENTIAL 3. HIGHLY DESIRABLE 4. DESIRABLE			
DISCREPANCY DESCRIPTION: PER SEMAT II UNDERWATER HULL ASSESSMENT: PORT SIDE (5-174-0-E) MAIN ENGINE ROOM 1								
BETWEEN WEB FRAMES (196-204) FROM THE MARGIN PLATE UP TO THE 4 TH STRINGER OUTBOARD OF MAIN ENGINE BLEED								
AIR PIPING. APPROXIMATELY 30 SF OF HEAVY RUST AND PAINT SEPARATION. U/T READINGS ARE

BLEED AIR PIPING BETWEEN WEB FRAMES (196-204). HEAVY CORROSION AND PAINT SEPARATION WAS DISCOVERED OUTBOARD OF PIPING.

WITHIN THE 25% WASTAGE CRITERIA. SEE DRAWING.								
RECOMMENDED REPAIRS: RECOMMEND SHIPS FORCE CLEAN TO BARE METAL APPROXIMATELY 30 SF OF AREA, PRIME AND PAINT								
SSPORT C221 POC: B. WILLIAMS (757) 396-4001 EXT 2166, TPOC: M. MELVIN (757) 396-4001 EXT 2128								
CSMP SUMMARY: CORROSION ON SHELL & STRINGERS BETWEEN WEB FRAMES (196-204) PORT SIDE.					TEST# MRC 1102/1			
ROOT CAUSE/AMPLIFICATION: H1					STEP# 1,2,3,4 & 5			
SYSTEM LEVEL IMPACT:								
PART NO.	NOMENCLATURE			QTY	NSN		COST	
1								
2								
3								
4								
5								
6								
FIRST CONTACT BAILEY		RATE DC1	SECOND CONTACT WATSON		RATE HT1	PHONE		
ASSESSOR / ACT / TECH ID# J. LaROCK/ T. ILGENFRITZ QED SYSTEMS INC.				TD	TL	LOGISTICIAN	TSP
